PREPRODUCTION TESTS OF THE BDU-41/B PRACTICE BOMB

TECHNICAL REPORT NO. AFSWC-TR-69-8

August 1969

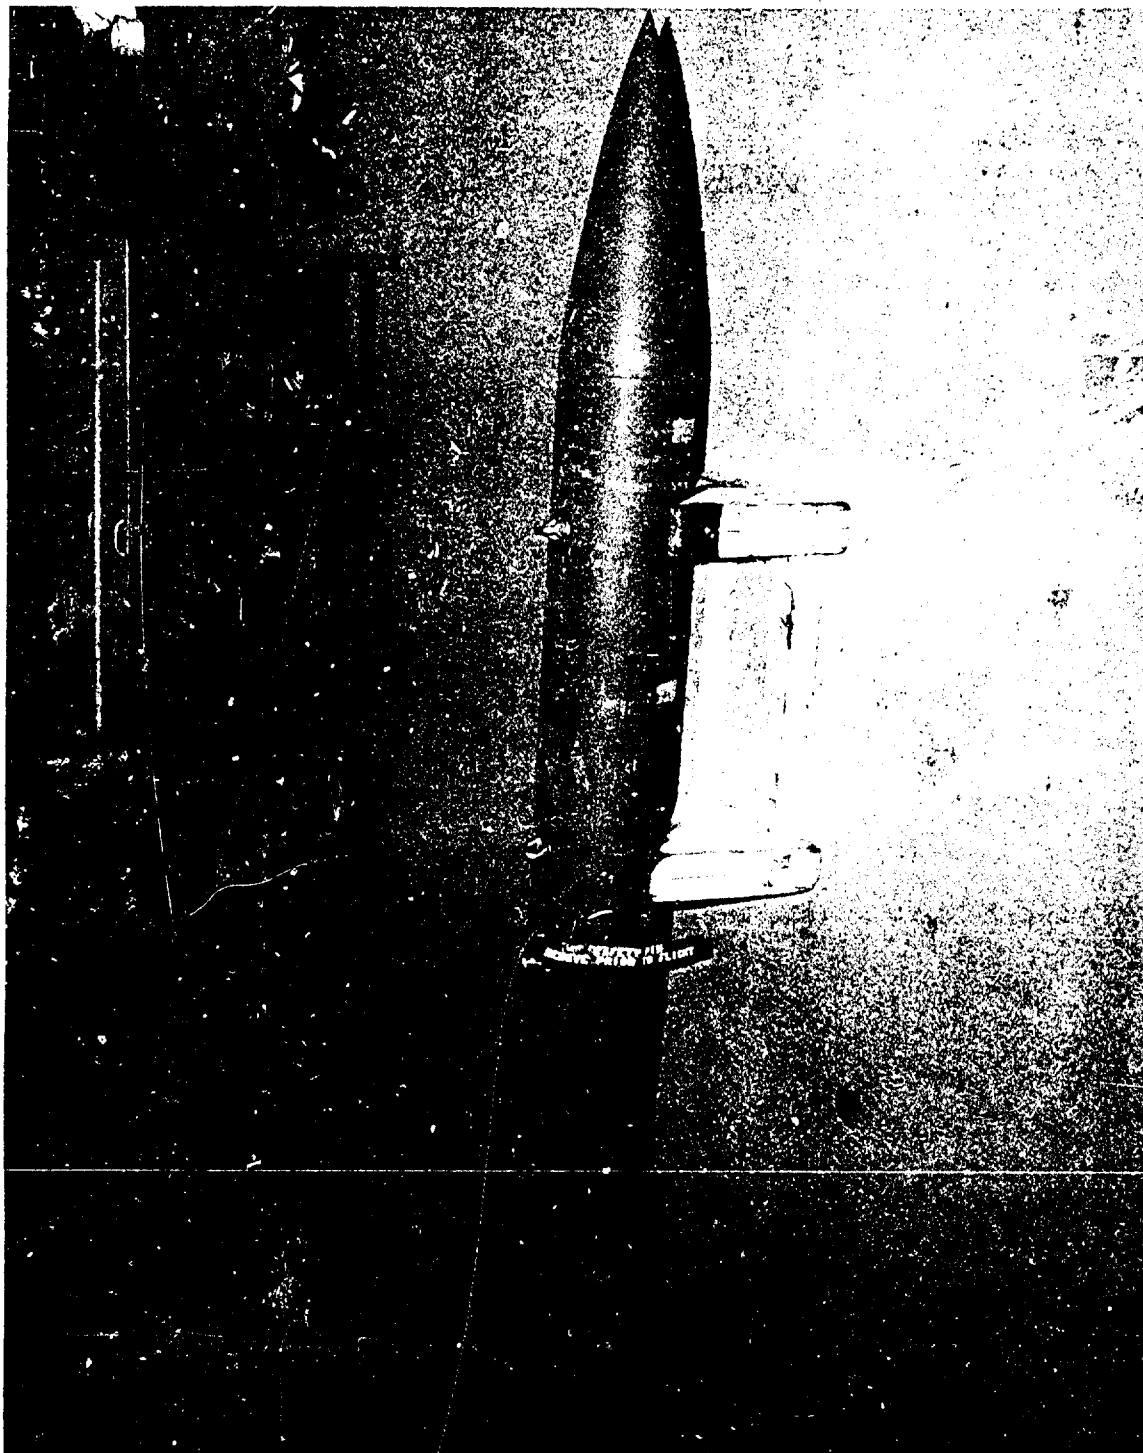
Figure 1. BDU-41/B

To determine that design of the BDU-41/B (figure 1) is satisfactory for large-scale production, the Air Force Weapons Laboratory requested the Air Force Special Weapons Center to subject a prototype BDU-41/B to measurements and tests according to the following specifications:
